## WSRC Lessons Learned Program Information System

**Title:** 9975 Shipping Containers Vibro-Etched Markings  
(Submitted by SRNL Instrumentation & Equipment Systems)

**Identifier:** 2008-LL-0043 (Special Information Notice)

**Date:** 5/14/2008

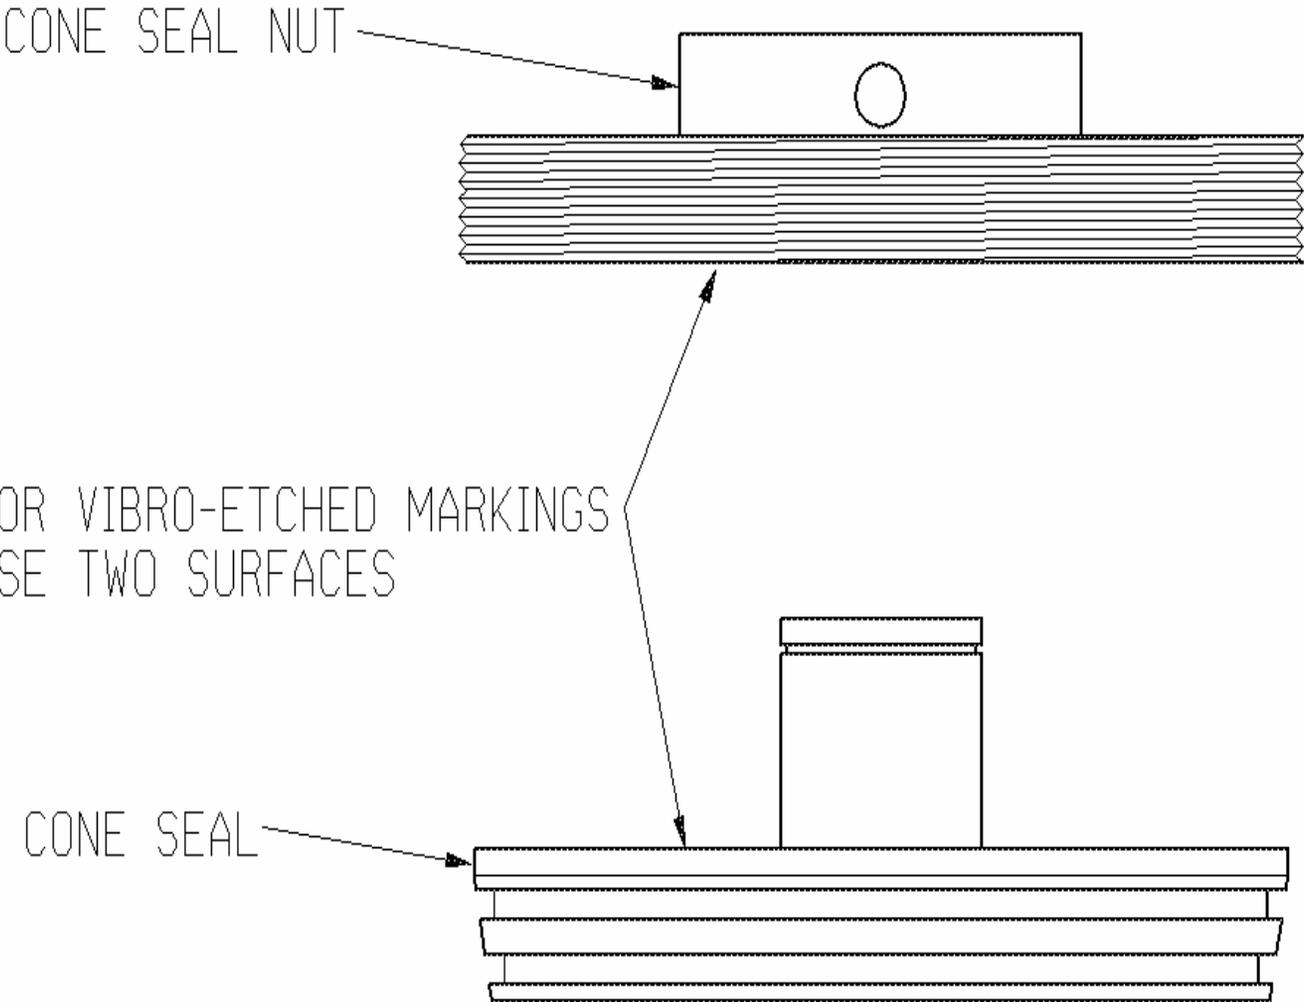
**Vibro-Etching, Attachment 1**

In 2004, fabrication of 9975 shipping packages at Joseph Oats Corporation was temporarily halted. To keep track of the many parts that were being processed at the time, the manufacturer vibro-etched match-marks on the bearing surfaces of the cone seal nut and plug of up to 400 shipping packages with serial numbers between 9975-03000 and 9975-05400.

The vibro-etching resulted in the parts not meeting surface finish requirements for these bearing surfaces.

The vibro-etching resulted in raised metal edges that protrude above the bearing surface. These raised edges diminish the required surface finish and could lead to galling on the adjoining bearing surface. Correct this condition by removing the raised edges with fine grit abrasive. Do not attempt to completely remove the markings below the finished surface as this would remove too much metal. The depressed areas of the vibro-etch markings that are left will not affect the safety performance of these parts. After refinishing, clean the surfaces with ethyl or isopropyl alcohol and a lint-free cloth to remove debris.

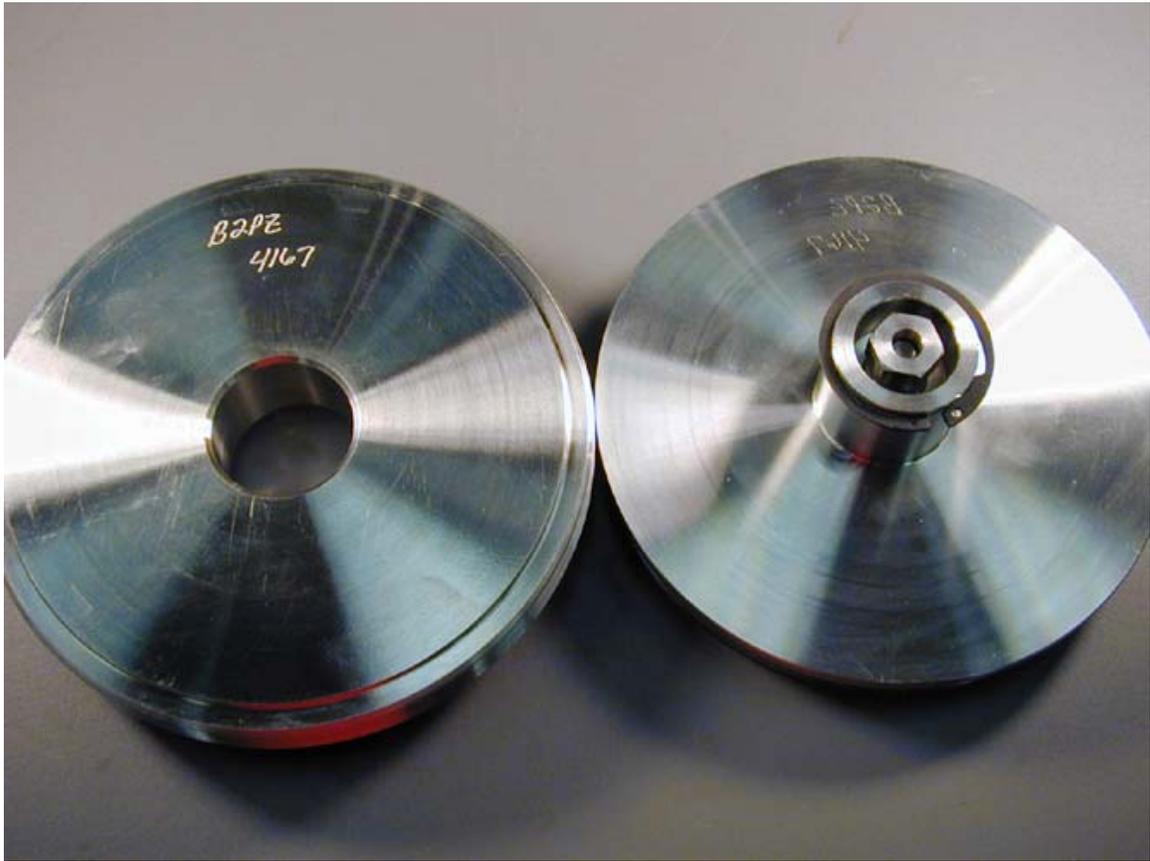
**Vibro-Etching – Attachment 2**

**See Attachment 2. Notice reverse image of vibro-etch on mating part caused by fabricator hydro pressure testing.**

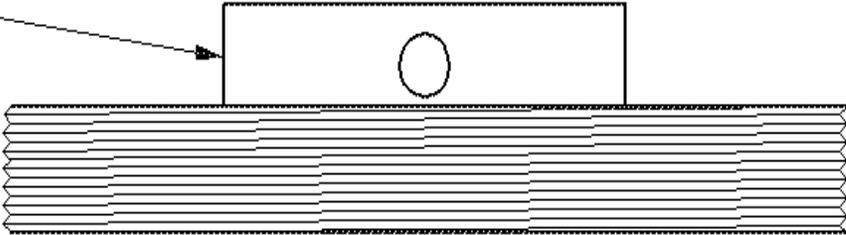
CONE SEAL NUT

LOOK FOR VIBRO-ETCHED MARKINGS  
ON THESE TWO SURFACES
