Mechanical Analysis of a
Transportation Accident Involving
Empty Shipping Casks for
Radioactive Materials Near Hilda,
South Carolina, in November 1982

MAJOR CONTRIBUTORS: Carl F. Walters and Howard H. Wiley

Prepared for
U.S. Nuclear Regulatory Commission

Prepared for
Division of Fuel Cycle and Material Safety
Office of Nuclear Material Safety and Safeguards
U.S. Nuclear Regulatory Commission
Washington, D.C. 20555
NRC FIN No. A0291

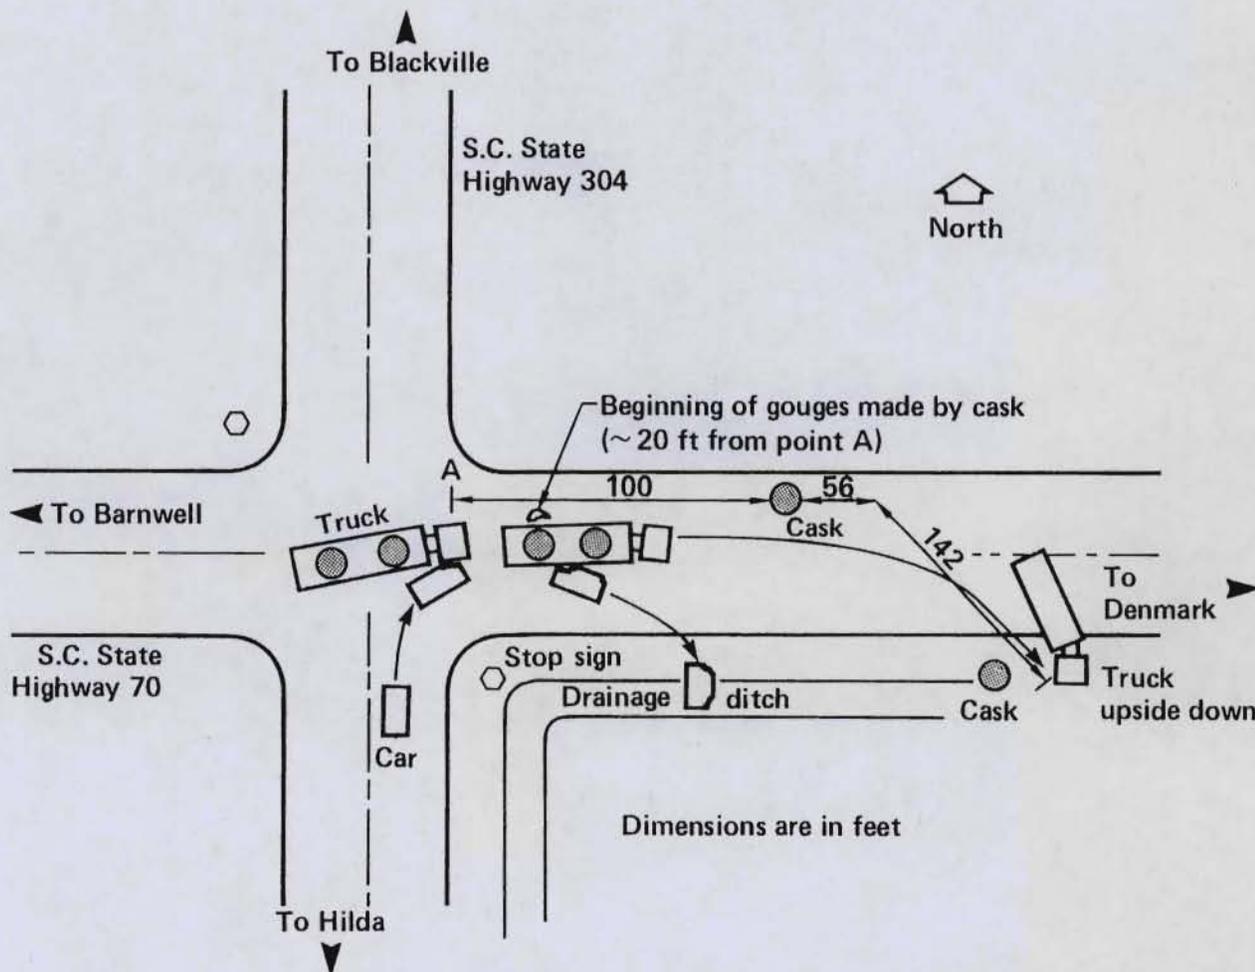
Figure 1. Diagram of the accident scene.

A diagram of the accident scene is shown in Fig. 1. Figures 2 and 3 are photographs of the damaged tractor-trailer and automobile, respectively, taken shortly after the incident.

Markings which remained on the road surface show that the tractor-trailer overturned shortly after the initial impact with the automobile and slid along the centerline of the road for about 156 ft. The tractor-trailer then began sliding in a curved path to the right, moving off the road. The tractor-trailer eventually came to rest upside-down with the tractor in the drainage ditch on the south side of State Highway 70. The trailer remained attached to the tractor and damaged a portion of the highway as it slid off the edge of the road. The front of the trailer was in the ditch, and its rear

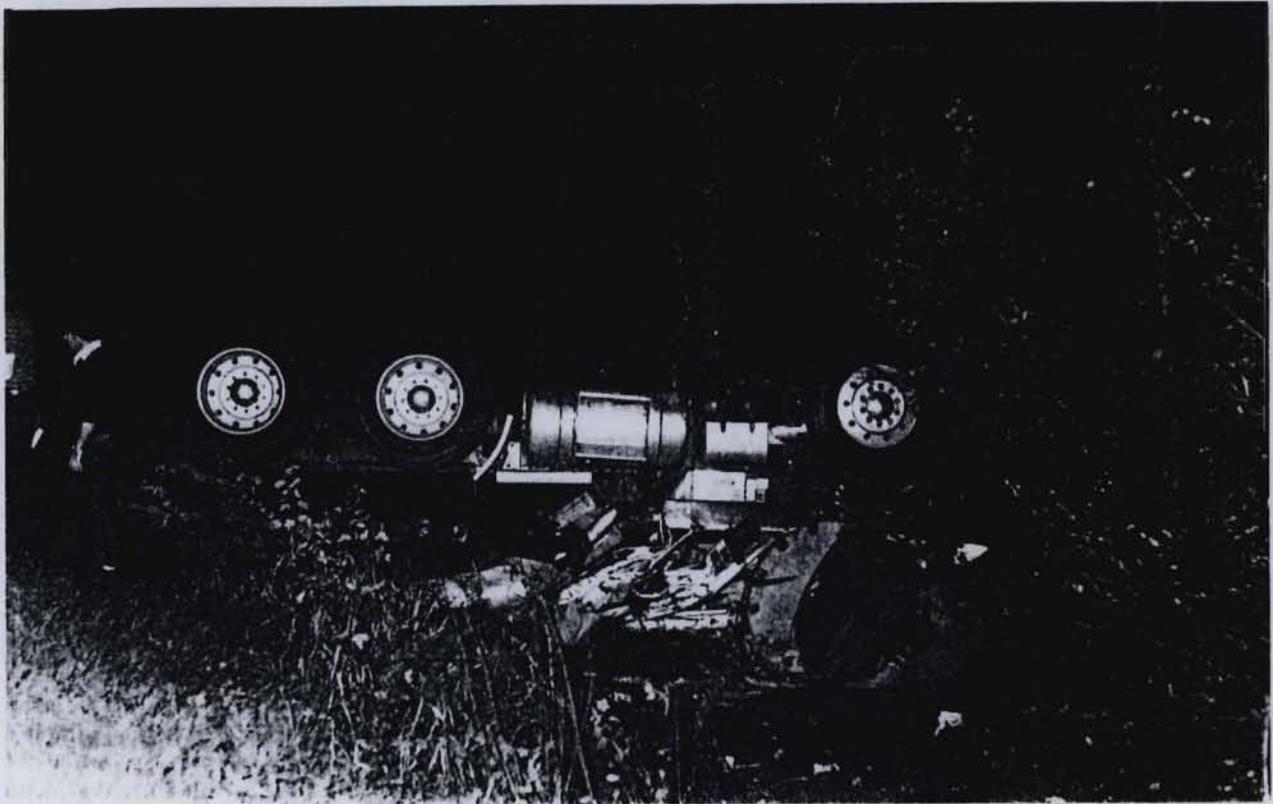
- The tractor-trailer overturned after the collision with the automobile. It eventually came to a stop upside down at a right angle to the roadway in a drainage ditch on the south side of State Highway 70. The total distance from the initial point of impact to the final resting point was about 300 ft. The tractor and trailer were severely damaged, and the driver was killed. The tractor-trailer combination remained attached.

Figure 2. Two views of the damaged tractor.

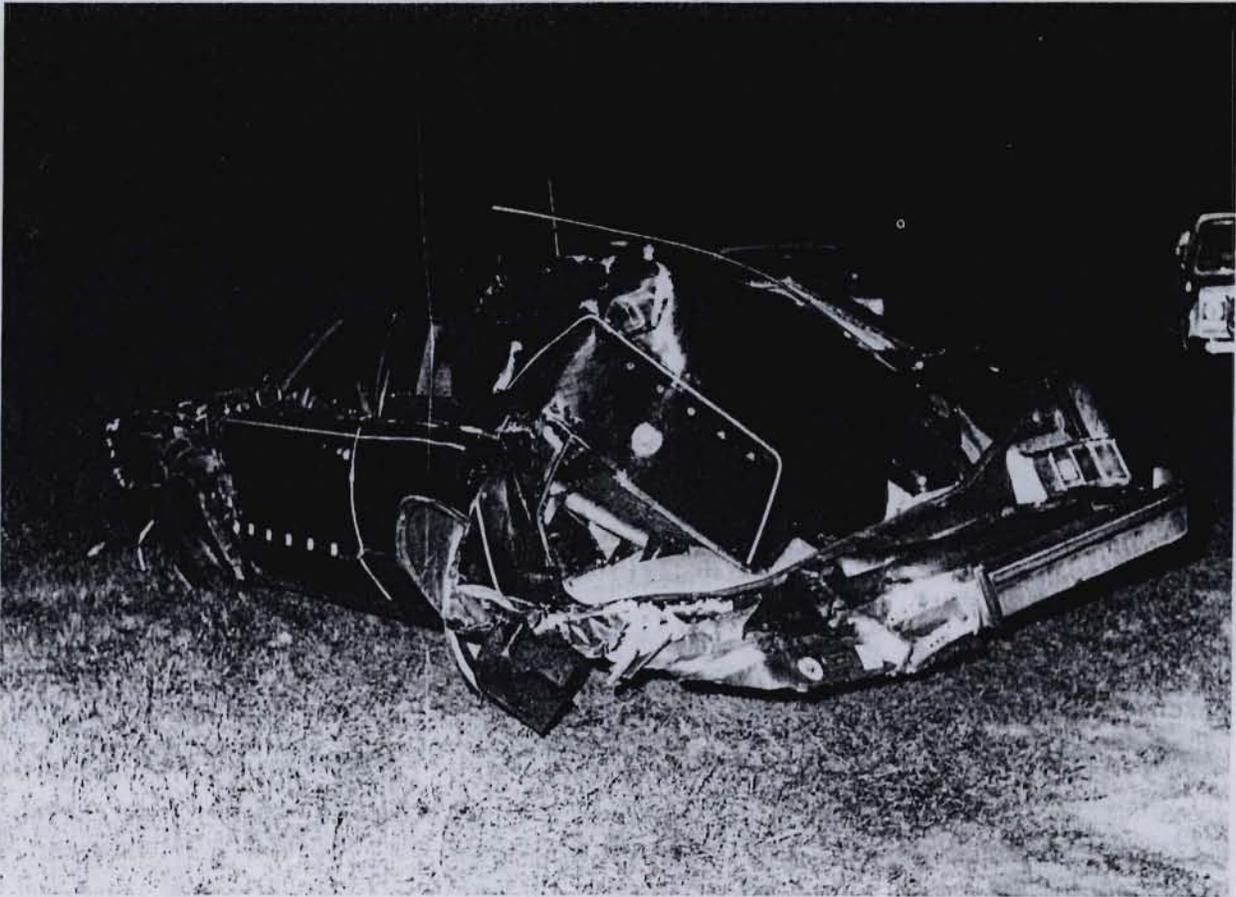
- The automobile received damage to the left front and left rear corners. The vehicle came to rest a few feet onto the shoulder of the roadway at a right angle to State Highway 70. There was one passenger in the automobile besides the driver; neither was seriously injured.

Figure 3. The rear of the automobile was severely damaged.

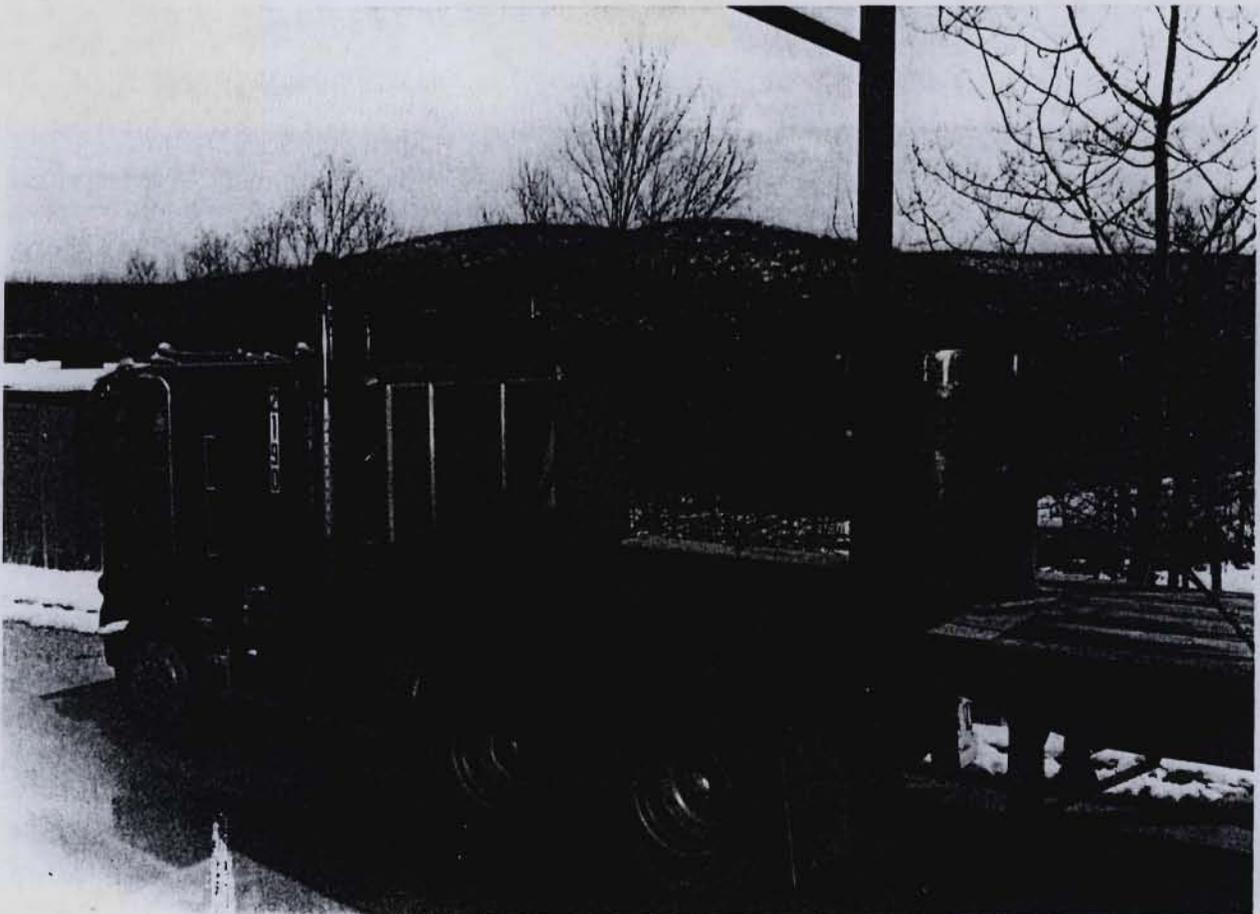
Figure 4. The loaded trailer showing cask tie-down method.

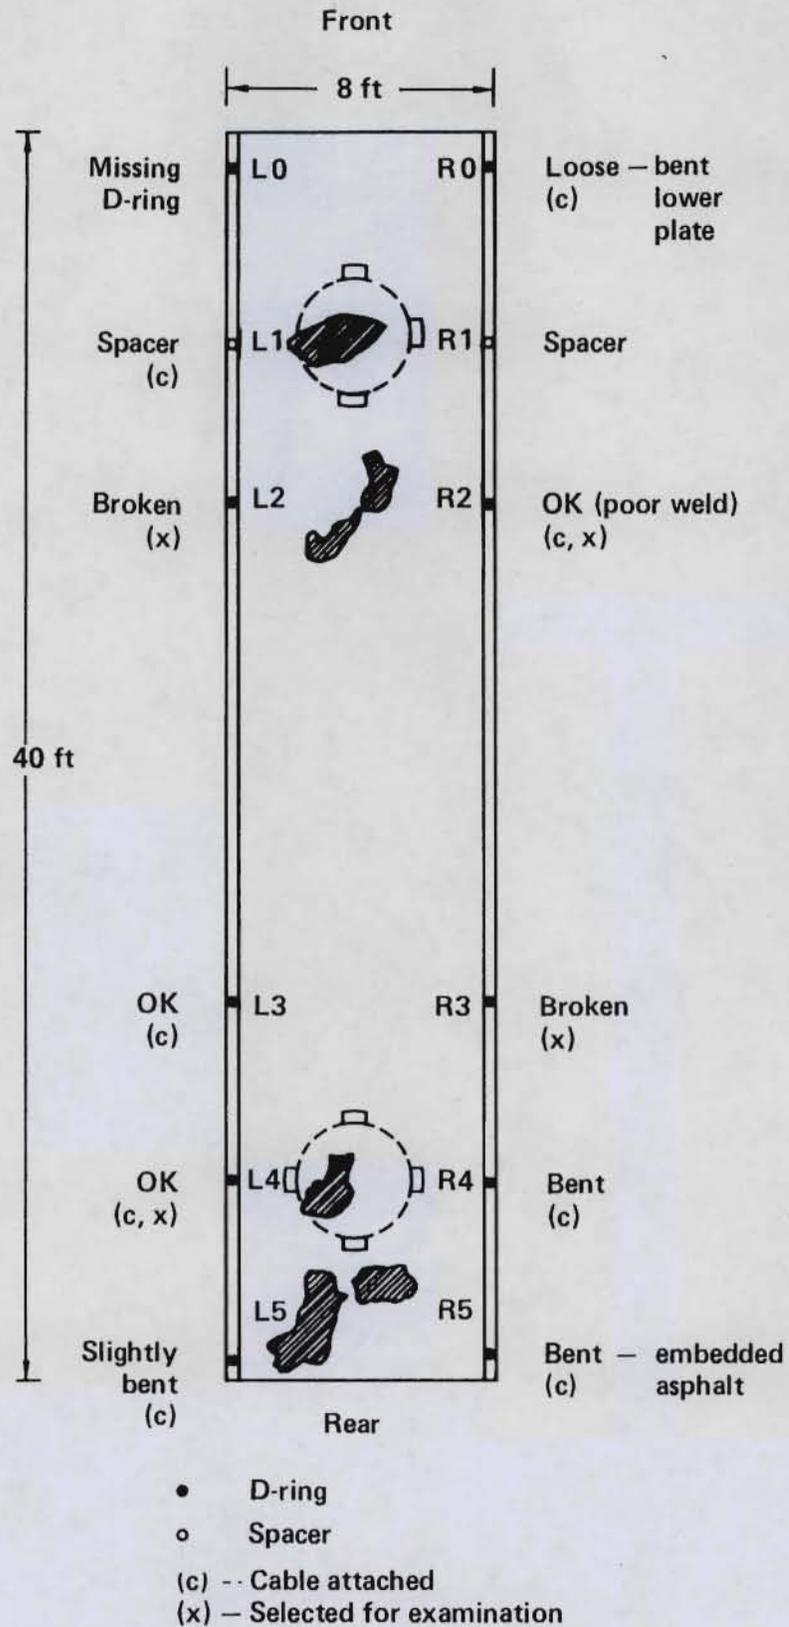
A diagram of the damaged trailer is shown in Fig. 6. The cask tie-down cables had been attached to the trailer using lugs called "D-rings." These consist of a 1-in.-diam steel rod in the shape of an inverted U which is welded to a steel plate that rests on the trailer bed. The legs of the U are threaded near their ends and project through a trailer tie-down rail. As can be seen in Fig. 7, which shows some of the damaged D-rings, they are secured to the trailer with two nuts and another steel plate on the bottom of the tie-down rail.

In two of the D-ring locations, welded steel cylindrical spacers were used. The spacers were welded to the trailer tie-down rail, and the cask tie-down cables attached directly to them. The rings which had been replaced by spacers were the center rings for the front cask.

Of the 10 D-rings used, 2 were broken, 7 were bent by various amounts, and 1 was missing after the accident.

Four of the damaged D-rings were removed from the trailer for further examination. These are labeled L2, L4, R2, and R3 in Fig. 6. The results of these analyses are discussed in a later section of this report. Also, it was noted that asphalt remained in the D-ring in the right rear corner of the trailer, and the left tandem dual wheel was damaged and the outside tire was flat. The cause of the damage to the wheel remains unexplained. The spare tire rack on the underside of the right side of the trailer was also bent, apparently as a result of the automobile striking it.

Figure 6. Diagram of the damaged trailer showing location and condition of tie-down devices.

Three of the D-rings from the damaged trailer were examined using conventional metallographic techniques to determine their cause of failure. The selected D-rings are labeled L2, L4, R2, and R3 in Fig. 6.

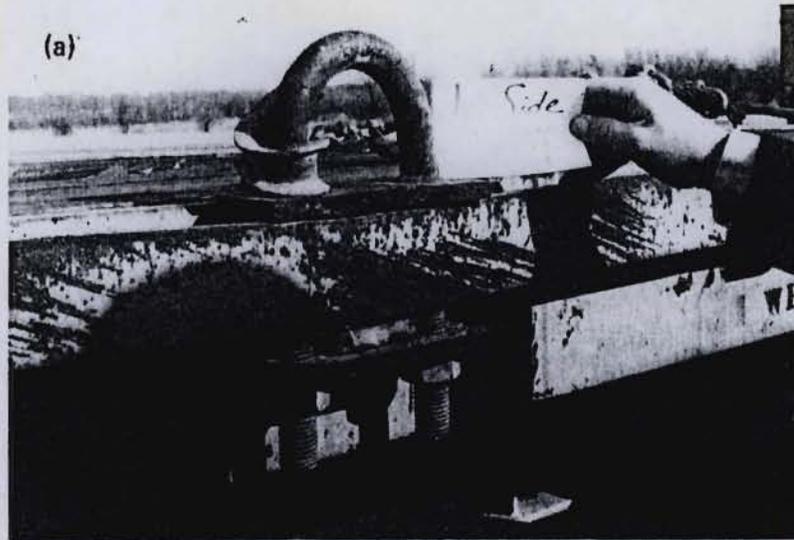
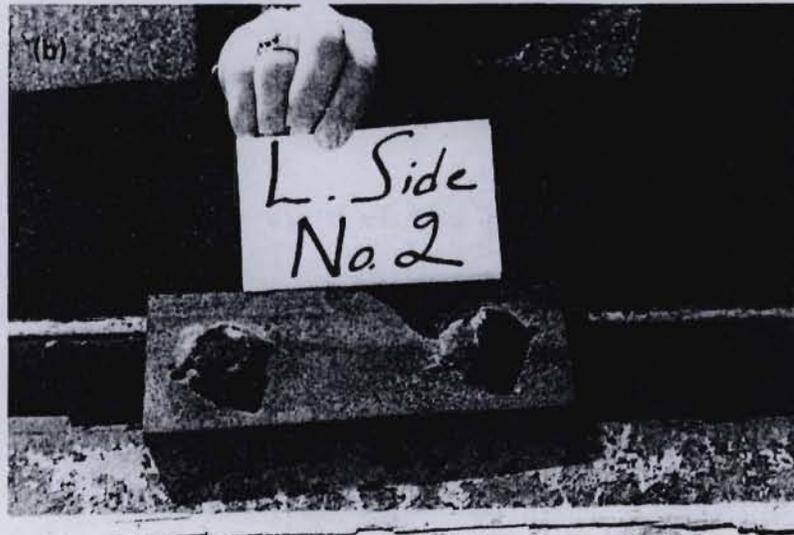
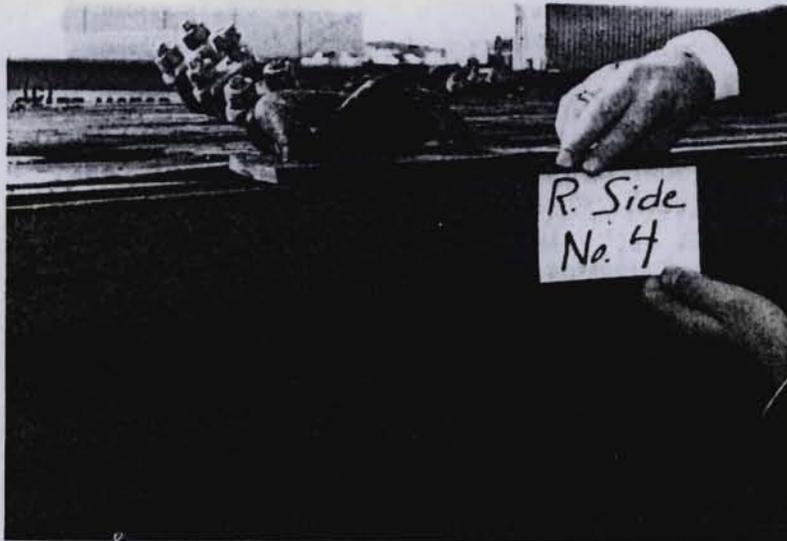
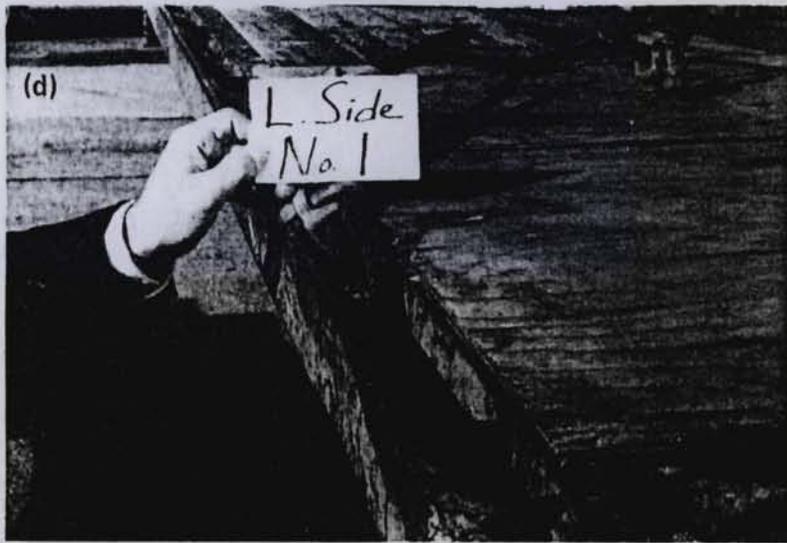
The cable assemblies are made by tying the cable ends into a loop with metal clips connected to a turnbuckle and ratchet binder. The ratchet is used by the truck driver to tighten the cables when securing the casks on the trailer. Failure of the cable assemblies to restrain the casks would result from a failure of either the ratchet binder, clips, cable, or D-ring. All of the failure modes were observed in at least some of the assemblies.

Figure 7. Various degrees of damage were observed in the D-rings: (a) undamaged; (b) D-ring broken off at weld to steel plate;

Figure 7. Various degrees of damage were observed in the D-rings: (c) D-ring severely bent; (d) one of two places where D-rings were replaced by spacers. This spacer was undamaged.

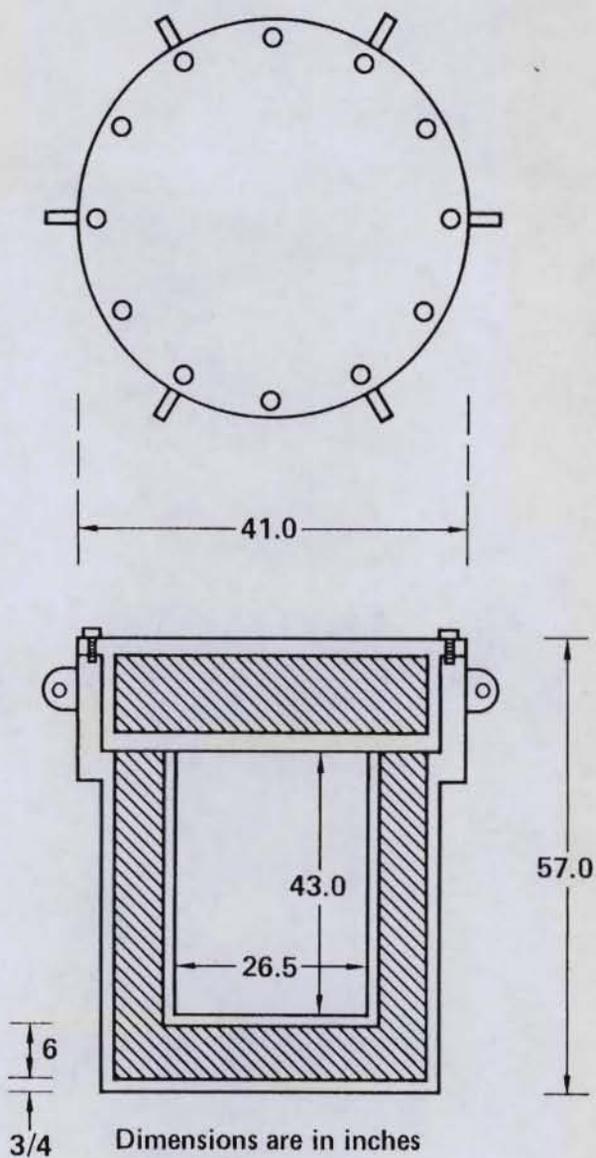
The basic cask body (excluding tie-down lugs) has a diameter of 41.0 in. and height of 57.0 in. It consists of two concentric stainless steel shells which form an annular region which is filled with chemical (pure) lead. The internal storage cavity is 26.5 in. in diameter and 43.0 in. high (sufficient size for a 55-gal barrel). The lead-filled annulus is 6-in. thick with equally thick sections of lead on top and bottom. The stainless steel shell of the cask is a laminate construction consisting of a 1/2-in.-thick inner layer and a 1/4-in.-thick outer layer. The laminate construction is used to improve the cask's thermal resistance to external fire exposure.

To minimize hazard in the event of a cask failure, the radioactive contents are cast in concrete which is then placed into the cask cavity. The weight of the cask when full is about 22 200 lb.

Figure 8. Diagram of the shipping cask.

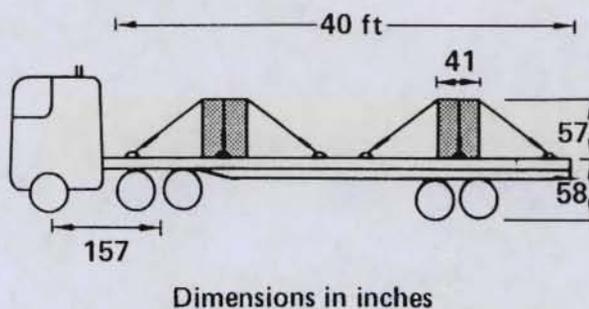
Figure 9. Position of casks on the trailer.

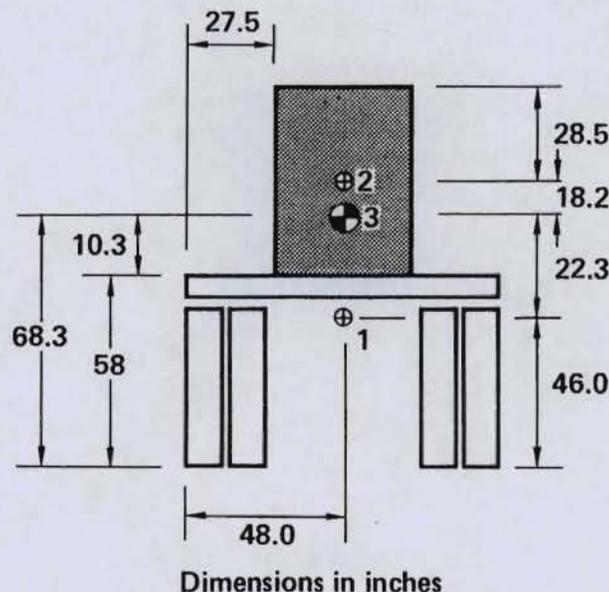
Center of mass locations

- 1 – Position for the empty tractor-trailer.
- 2 – Position for the empty casks.
- 3 – Position for the loaded tractor-trailer.

Figure 10.. Assumed mass distribution for the loaded trailer.

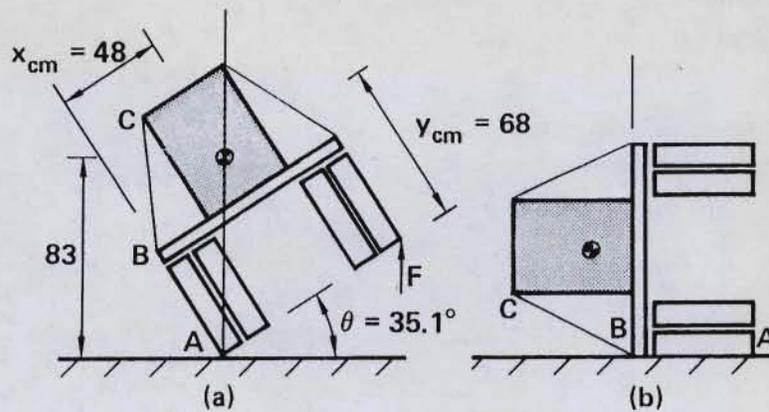
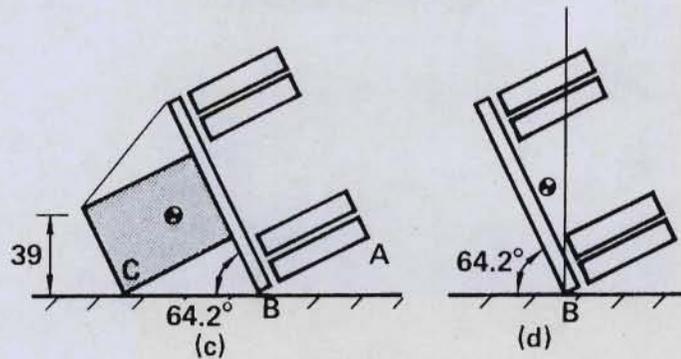
The modeled rollover is depicted in Fig. 11(a)-(d). For simplicity, we use a two-dimensional analysis and assume that the entire mass system rotates as a rigid body in the plane perpendicular to the direction of travel. As shown in the figure, the collision with the automobile is modeled as a force which imparts an impulse to the outside corner of the right wheel. This impulse causes the system to rotate about the opposite wheel at point A.

The minimum angle of rotation θ needed to initiate rollover is shown in Fig. 11(a). At this point, the truck center of mass is at its maximum height. For the mass distribution of the trailer and casks used in this case, $\theta = 35.1^\circ$.

After moving beyond the critical angle, the truck continues to rotate about point A until the left top corner of the trailer strikes the pavement at point B, as shown in Fig. 11(b). The truck then rotates about point B until the top edges of the casks strike the pavement at point C [Fig. 11(c)]. We assume that the casks initially remain attached to the trailer, so the center of mass location does not change until the moment when the casks struck the pavement.

Figure 11. Assumed sequence of positions during the truck rollover.

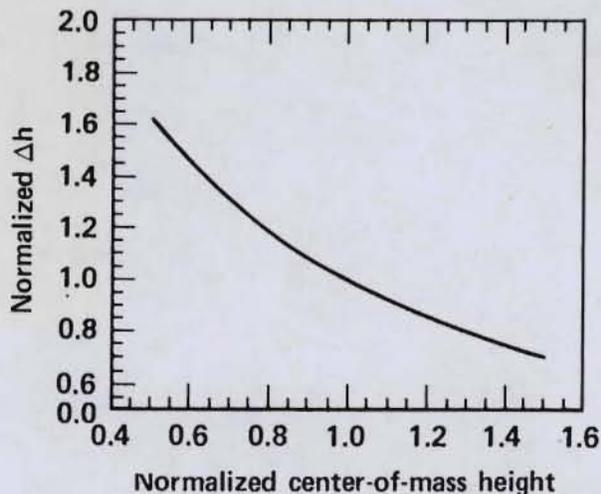
For the loaded tractor-trailer in this accident, $x_{cm} = 48.0$ in., $y_{cm} = 68.3$ in., and $\Delta h = 15.2$ in. Figure 13 shows the effect on Δh when the center-of-mass height y_{cm} is varied from one-half to twice its baseline value. The data are normalized by dividing the values of y_{cm} by 68.3 in., and the resulting values of Δh by 15.2 in. As can be seen in the figure, for example, if the baseline center-of-mass height is decreased by 50%, Δh increases by about 63%.

Figure 13. Normalized change in Δh vs normalized center-of-mass height.

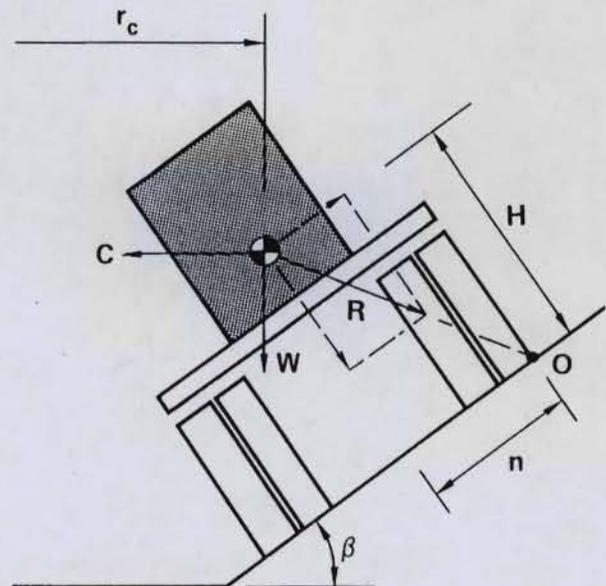
The dynamic forces acting on a vehicle during a turn are shown in Fig. 14. In the figure, we consider the general case where the curve is superelevated (banked), but assume that the velocity through the turn remains constant. For the curvilinear motion, the centripetal force (assumed to act through the

Figure 14. Dynamic forces acting on the tractor-trailer during a turn.

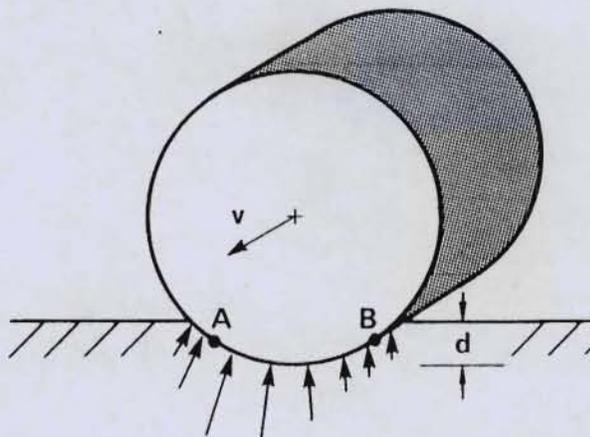
Figure 15. Idealized impact forces over surface of interaction for an oblique impact.

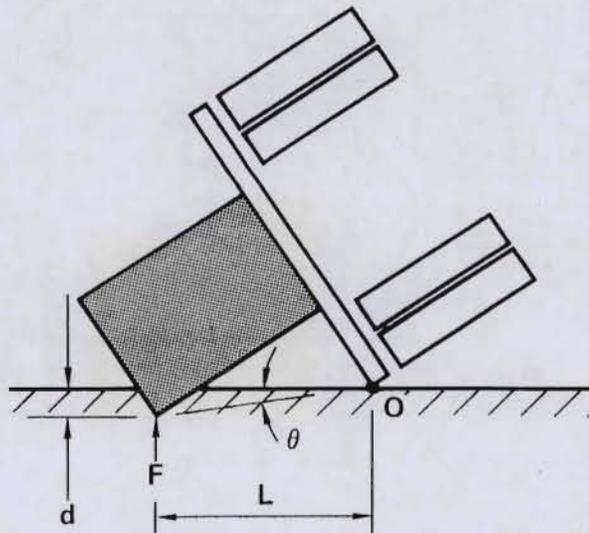
For the overturning vehicle, the impact force at the point of contact with the road produces a torque about the point of rotation O, as shown in Fig. 16. The work done by this torque is equal to the kinetic energy of rotation just before impact. Thus, the torque is equal to

Figure 16. Impact force for the assumed tractor-trailer rollover.

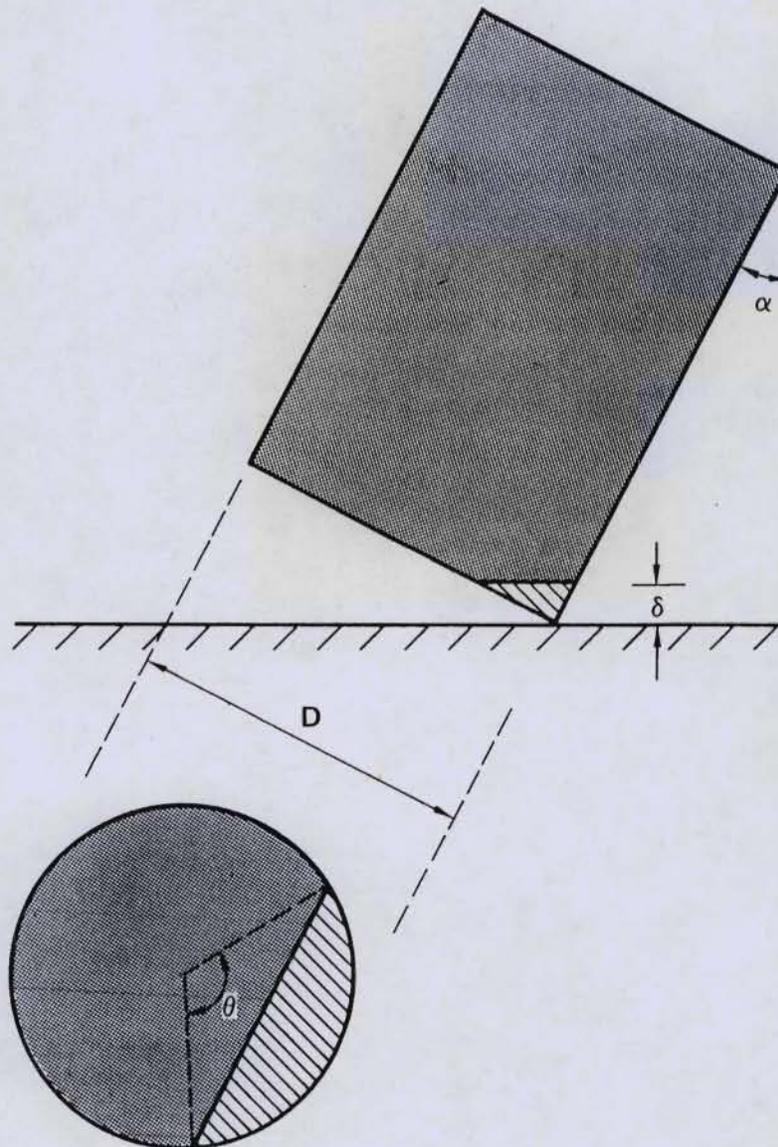
A bounding calculation of the cask shielding deformation is based on energy considerations. The kinetic energy of the cask during impact must be absorbed by the cask shell and shielding material (lead), or by the impacted media. For the bounding calculation, we assume that the impacted media is unyielding, and neglect the presence of the stainless steel shell. Thus, all the kinetic energy of the cask just prior to the collision must be absorbed by the lead shielding. Based on data from impact tests using lead, the capacity to absorb energy can be expressed as⁵

Figure 17. Deformation of the cask by an edge impact.

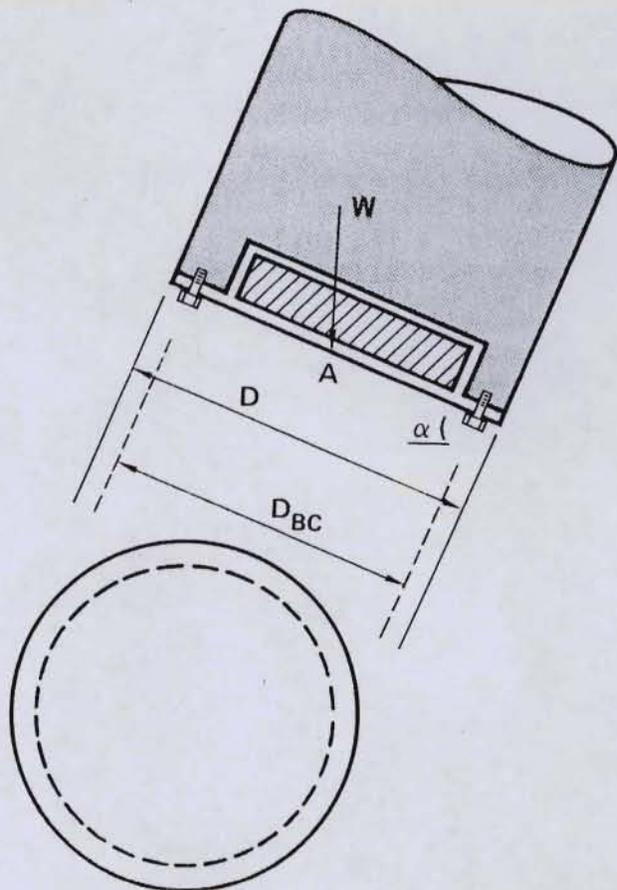
If the weight of the cover is conservatively assumed to act at point A, as shown in Fig. 18, the maximum tensile load on the bolts can be estimated.

Figure 18. Assumed loading due to the mass of the cover for an edge impact of the cask.

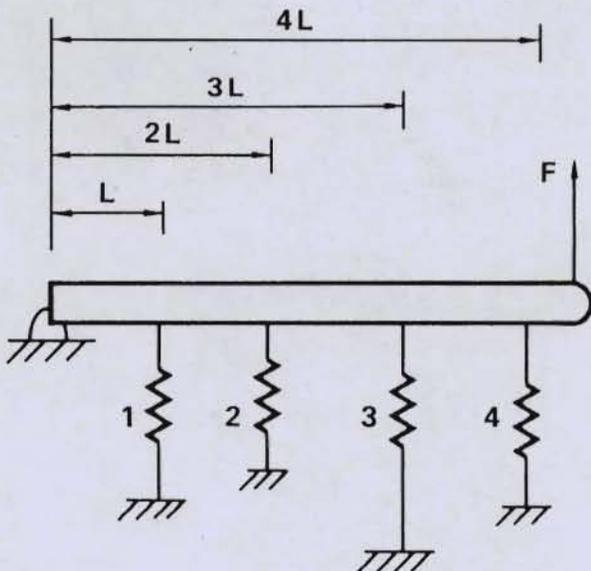
In this example, a hinged bar is attached to four cables of unequal length, which we model as linear springs. An upward force is applied at the unhinged end of the bar, and we wish to calculate the forces created in the four cables. One finds that this system is statically indeterminate, but by using the assumed spring model for the cables, the system can be solved.

For example, for small angles of rotation the amount of elongation will be proportional to the distance from the hinged end, and similarly for the forces in the cables, if the spring constant is assumed equal for all cables. The forces in cables 2, 3, and 4 can thus be expressed in terms of their ratio to the force in cable 1. With this assumption, the problem is reduced to one unknown force and the system can be solved by summing moments about the hinged point.

Figure 19. Example of spring system with indeterminate force distribution.

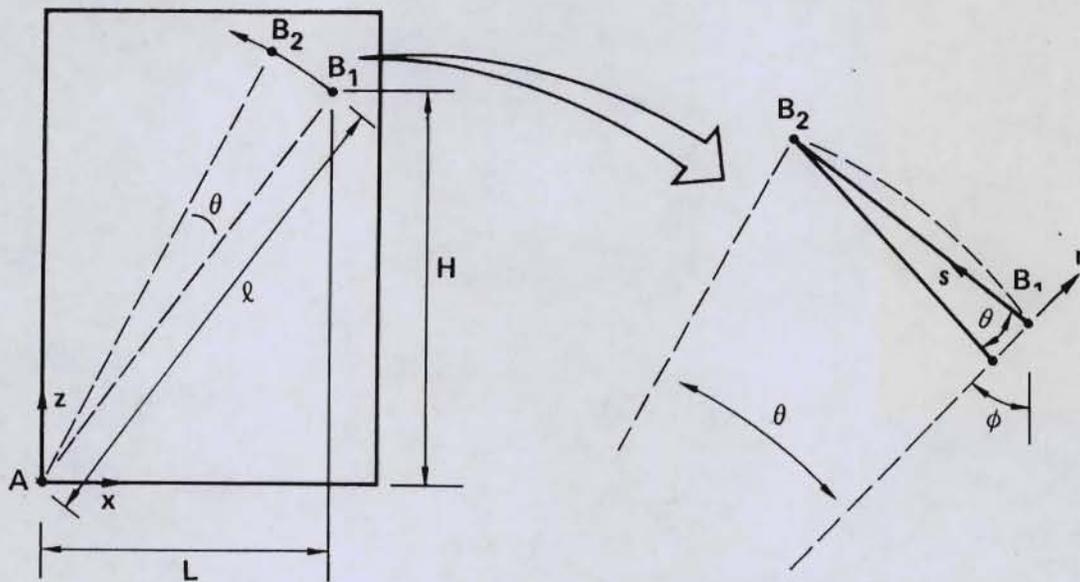
Figure 20. Geometric displacements for an incremental rotation of the cask.

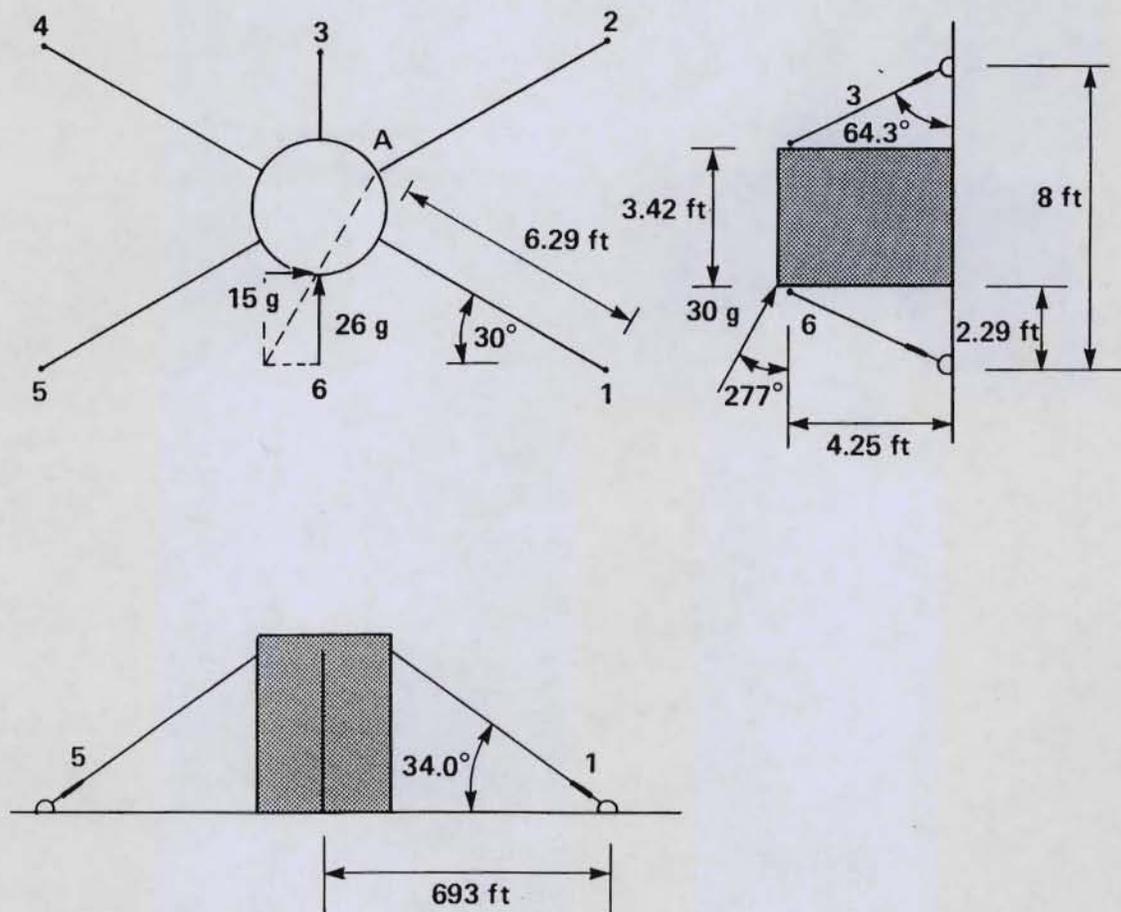
The cask tie-down configuration used on the trailer involved in this accident is shown in Fig. 21. For the impact force shown, it is assumed the cask will tip about the cable attachment point at A. The actual intersection of the cask edge and the resultant of the assumed impact force is a small distance (0.25 in.) from point A, but we assume that the cask rotates about this point since this simplifies the calculation greatly by virtue of symmetry.

The assumed impact force has components of 1.12×10^6 lb (30 g) in the direction perpendicular to the roadway, and 5.60×10^5 lb (15 g) in the direction parallel to the road. The orientation of this force with respect to the cask is as shown in the figure. The magnitude, point of application, and direction of the impact force were determined in previous sections of this report.

Figure 21. Configuration of the cask tie-down cables and the assumed impact force.

For the assumed impact mode, it is found that only cables 4, 5, and 6 will be loaded. For the numbered cables the estimated loads in pounds are

The maximum estimated cable load is 236 000 lb. The tie-down cables are 5/8-in. rope made of plough steel with a breaking strength of about 26 000 lb,¹⁰ while the ratchet binders used to connect the cables to the trailer D-rings break, according to their manufacturer, at 23 000 lb.⁹ Since these ratings are well below the estimated loads, the cables would be expected to fail in an accident such as this involving a rollover.

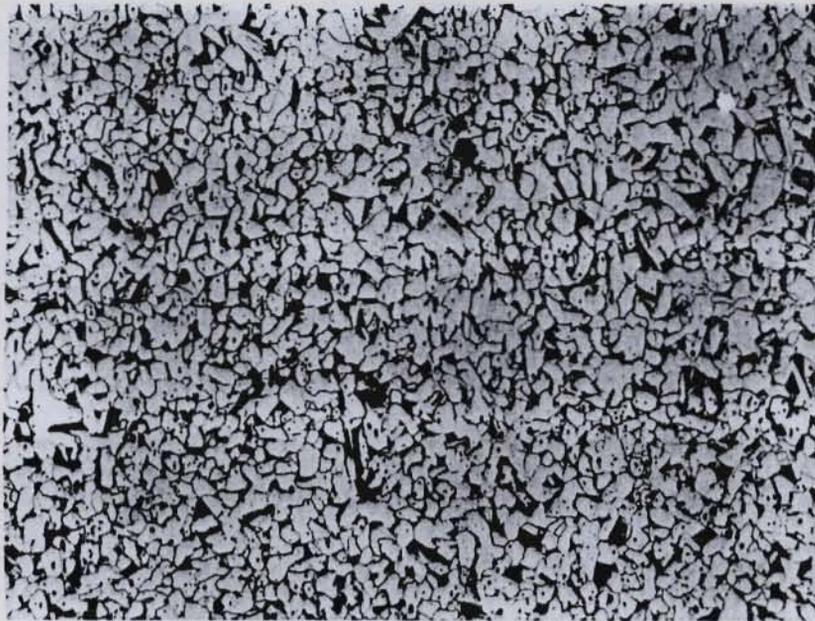
No information was available on the type of material used to make the D-rings, but their microstructure resembles that of AISI 1018 steel. Figure 22 shows the microstructure for one of the rings.

Figure 22. Microstructure of the D-ring material (100X).
